Why Orion BMS Internal Fuses Blow

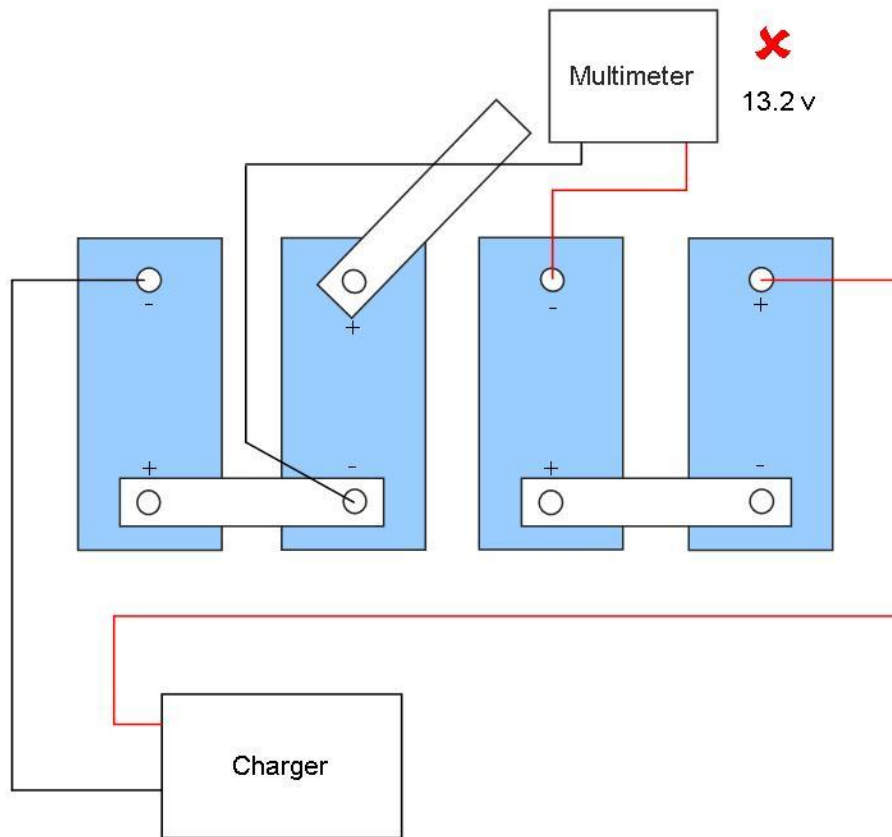
The next diagram shows what happens when the busbar is disconnected. As the busbar is now open, battery voltage is no longer present at the battery charger, but the internal capacitors in the charger are still charged at the pack voltage (13.2 volts) and have no place to discharge. Because of this, the full battery voltage is present across cell tap #1 and #2 (the multimeter leads in the diagram). Because the voltage is now the full battery voltage, the zeners inside the BMS break down and conduct, causing the fuses inside the BMS to blow.

In the above example, the total pack voltage is only 13.2 volts, which would blow fuses in a revision C or D unit, but likely would not damage a revision E unit. If this same scenario were to occur on a higher voltage battery pack, internal fuses on any revision of the Orion BMS will blow as the voltage would exceed 24 volts. The below electrical diagram shows the same situation, only with a larger 158v battery pack. When the voltage between the cell taps rises rapidly, the zener diodes inside the BMS begin to conduct, discharging the battery charger's capacitors, resulting in blown fuses. In this case, it is possible to blow all fuses within a particular cell group. Typically current will first flow through the two closest cell taps as it is the path of least resistance (black line in the following diagram) and then seek alternative paths as fuses blow (light purple line.)

It is very important, both for safety and for the health of the BMS, that all cell tap wires are always disconnected before any modifications are made to the wiring of the battery pack. We recommend designing the battery box enclosure to require the cell taps to be disconnected before the battery wiring can be modified or applying warning stickers throughout the battery pack indicating that the BMS must be disconnected before the battery pack is serviced.

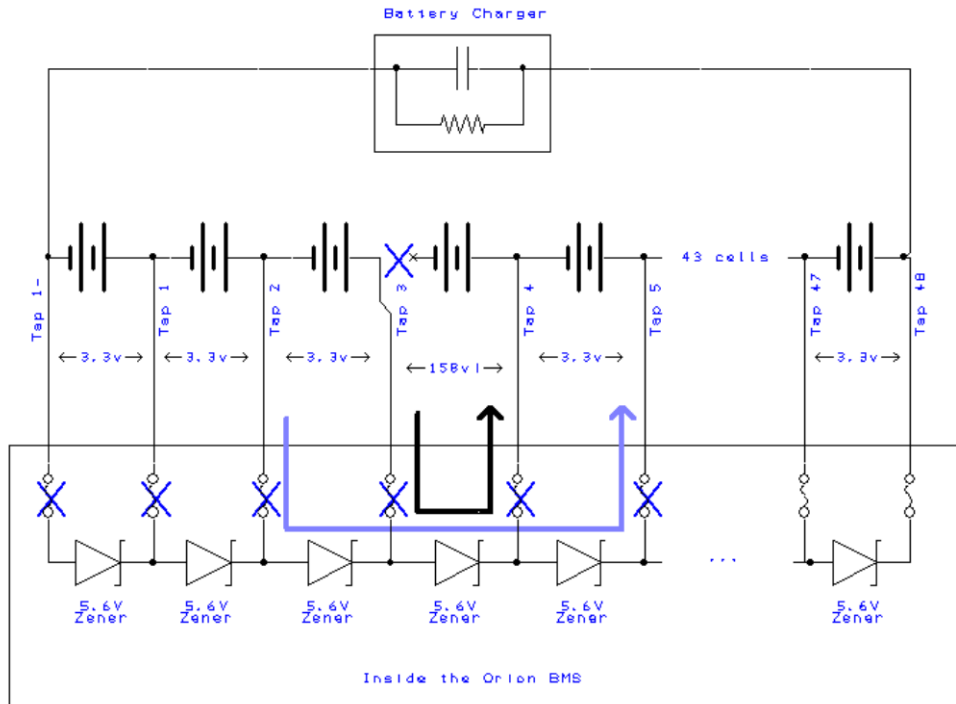
It is important to note that a battery charger or load does not need to be connected to the battery pack to cause high voltages between cell taps when a busbar is removed. Isolation faults, built up charge against the chassis (stray capacitance), or capacitors on snubber circuits can all be enough to cause damage. Damage from this can be prevented by ensuring that the cell tap harnesses are fully disconnected from the BMS before any wiring is altered on the battery pack. Additionally, this can be caused by intentional re-wiring of the battery pack or by loose busbars (which also pose a fire risk from arcing.)

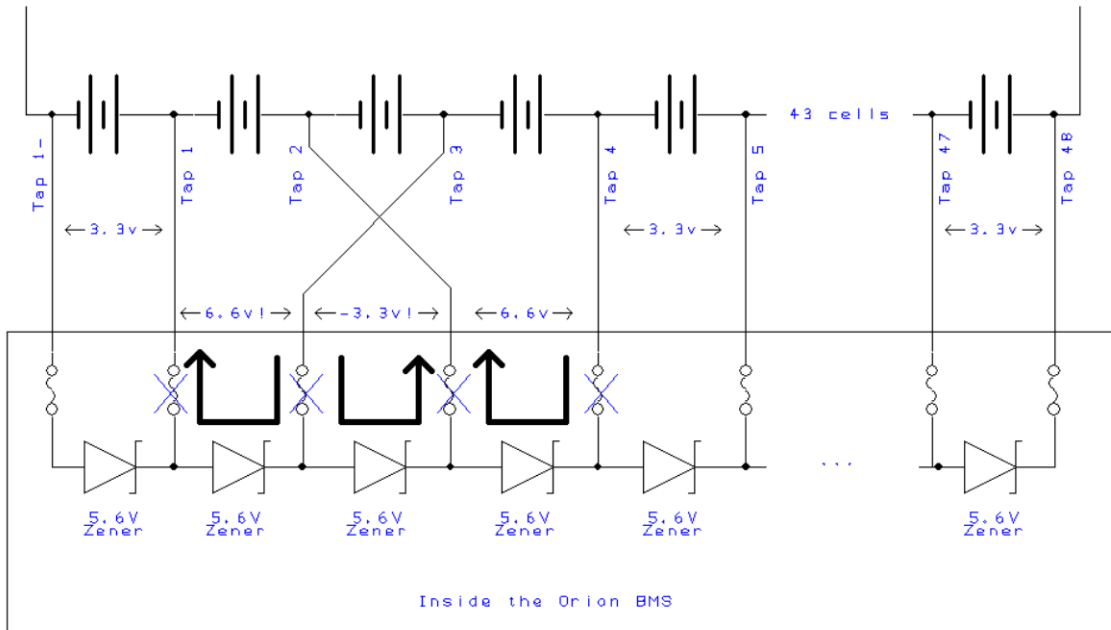
In the above schematic, cell taps 2 and 3 are reversed. This leads to 6.6v between cell taps 1 and 2 and 3 and 4 with a reverse voltage between taps 2 and 3. In this case, 4 of the zener diodes will conduct and current will flow through the tap wires. This condition leads to up to 4 fuses blown (but may be as few as 2 fuses depending on the order that they blow.) For revision E units, fuses will generally reset to their normal state once the above fault is fixed.

For revision C & D units, reversed cell tap wires will lead to a blown fuse. While revision E units are designed to survive a single tap wire reversed for short periods of time, the unit may not survive for longer times or if multiple wires are crossed. Never leave a BMS unit connected with reversed tap wires. Even though the BMS may survive, this condition will drain attached cells.
