Why Orion BMS Internal Fuses Blow

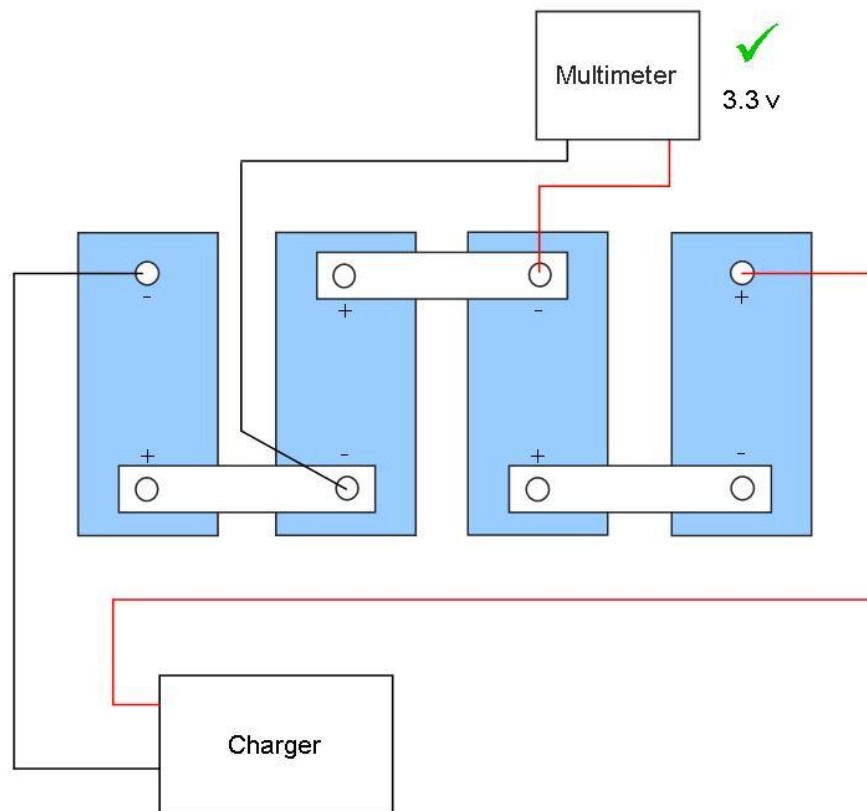
The below example shows a 13.2 volt battery pack. A volt meter is measuring 3.3v from cell tap #1 to #2 in the example.

It is very important, both for safety and for the health of the BMS, that all cell tap wires are always disconnected before any modifications are made to the wiring of the battery pack. We recommend designing the battery box enclosure to require the cell taps to be disconnected before the battery wiring can be modified or applying warning stickers throughout the battery pack indicating that the BMS must be disconnected before the battery pack is serviced.
