Diagnosing State of Charge Calculation Jumps

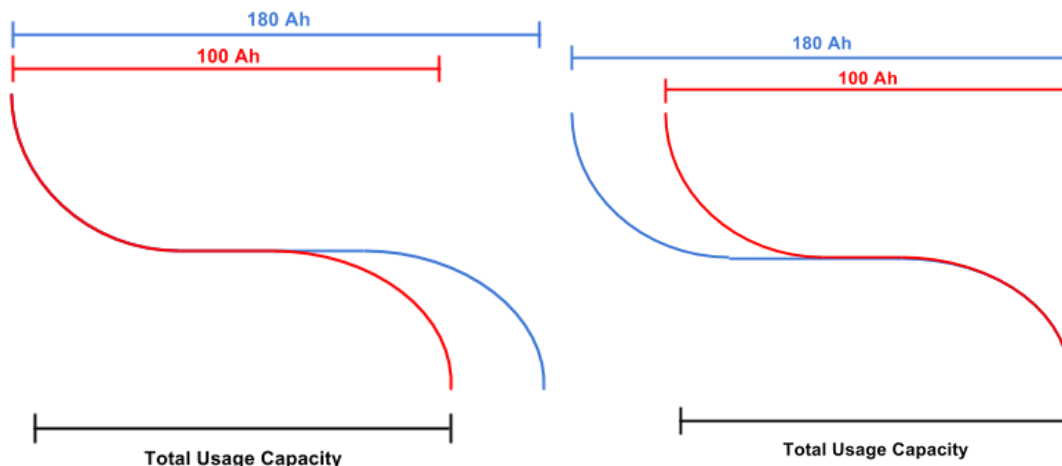
1. A drift may occur if one or more cells within the battery pack has a lower capacity than the others. The battery pack is only as strong as the weakest cell, because the weakest cell cannot be over charged or over discharged. If a cell has a lower capacity than the rest of the pack, the weak cell will cause the BMS to correct the state of charge on the high end or on the bottom end depending on how the cell is balanced. The 2 images below show a top balanced and bottom balanced iron phosphate cell. A drift will occur at 100 amp hours in both cases since the weakest cell is only 100 amp hours. The remaining 80 amp hours is not usable since one cell’s voltage would exceed the allowable range.

The above charts show a theoretical view of the cells, however in the real world, it is not possible to see the full chart as discharge must cease as soon as the lowest cell reaches the minimum cell voltage, as not to damage the cell. In the above case, discharge must stop when the red cell reaches the minimum voltage. This means that only the section of discharge prior to that point will be visible when plotting the discharge graph. When a low capacity cell is suspected, it is best to graph an entire charge when the red cell reaches the minimum voltage. This means that only the section of discharge prior to that point will be visible when plotting the discharge graph. When a low capacity cell is suspected, it is best to graph an entire charge and discharge cycle to determine if the cell truly has a lower capacity than the rest of the pack or if the pack is simply out of balance. The two can appear very similar if only looking at the discharge or only at the charge end. If the cell is at a lower capacity than the rest of the pack, either

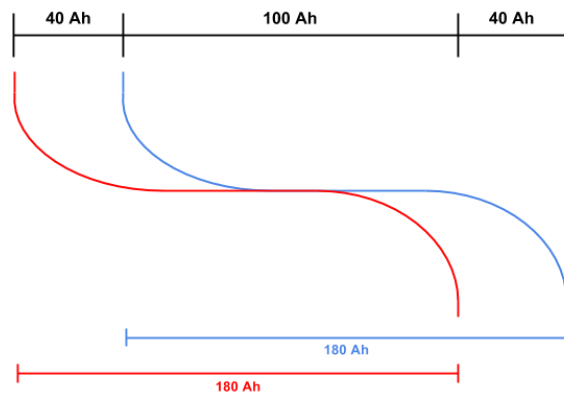
2. A drift may occur if the battery pack is out of balance. If one cell is at 70% state of charge, and another cell is at 30% state of charge, less than 50% of the battery is usable without one of the cells getting too high on the high end or too low on the low end. This limits the usable range of the battery and results in a lower capacity than the BMS is expecting, which requires the BMS to adjust the calculated state of charge. During discharge, as the BMS sees the lowest cell's open circuit voltage drop to a known correction drift point, the BMS will correct the state of charge showing that the battery is nearly depleted. The same will happen during charge due to a high cell voltage. In the example below, while the cells are 180 amp hours in size, two cells are 40 amp hours out of balance with each other and only the middle 100Ah is usable before a cell voltage becomes too high or too low. In this example, SOC corrections would occur at the both ends of the 100Ah usable range. This would be due to the blue cell on the high voltage and the red cell at low voltage.

The above graph shows the theoretical curves. In reality, only the middle section labeled “100 Ah” is visible since charge must stop when the blue cell reaches its maximum voltage and discharge is limited by the red cell dropping to its’ minimum voltage. It is important to graph an entire charge / discharge cycle to determine if a cell is simply out of balance or if it actually has a lower capacity than the rest of the pack.

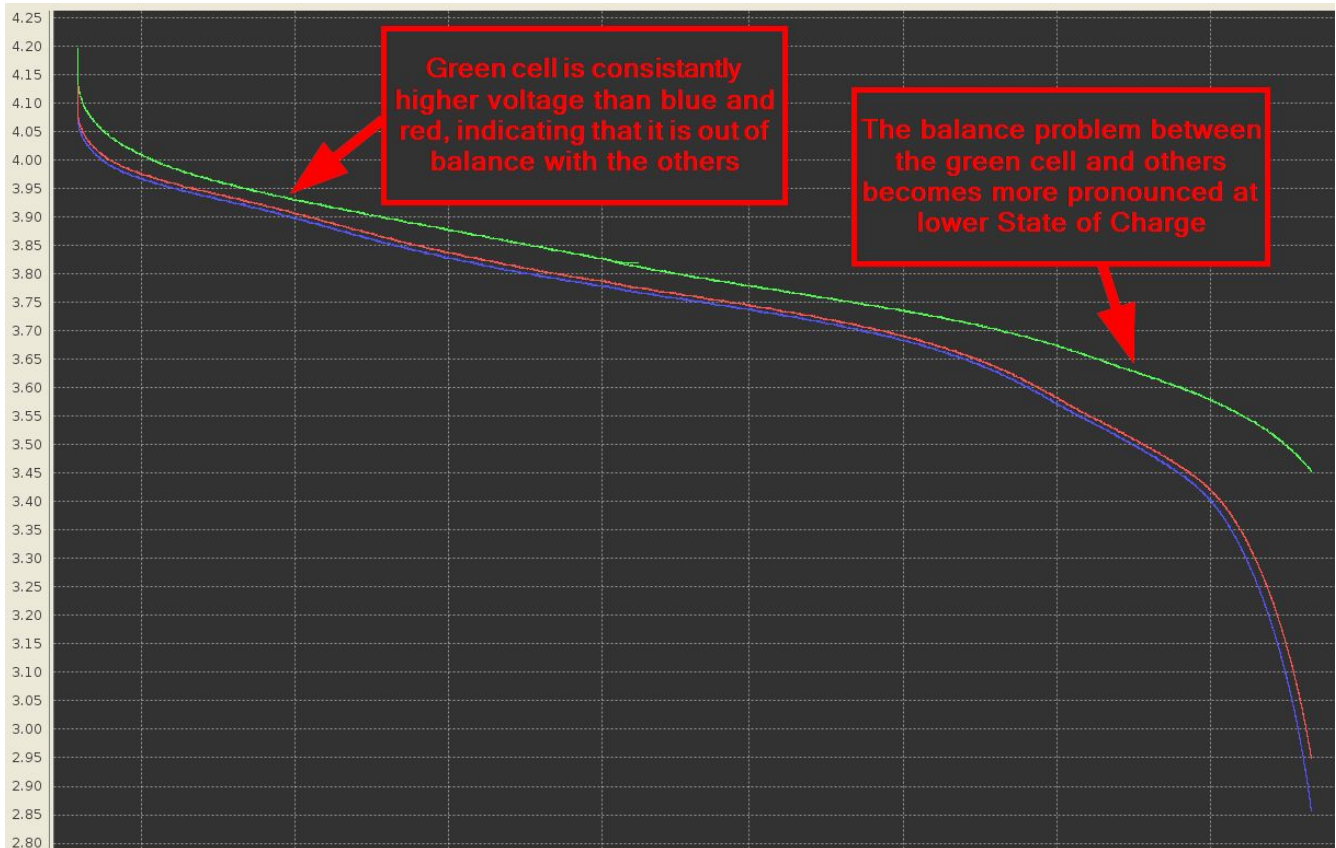
In this example, the green cell is at a slightly higher state of charge than the red and blue cells. This can be determined by the cell being the highest voltage both at the top of the state of charge **and** at the bottom of the state of charge (if the issue were related to cell capacity, it would be equal or high on one end and low on the other). The shape of the discharge curves are approximately the same for each cell, so the amount of imbalance can be estimated visually in the above graph (though this is far more difficult when currents are not steady.)

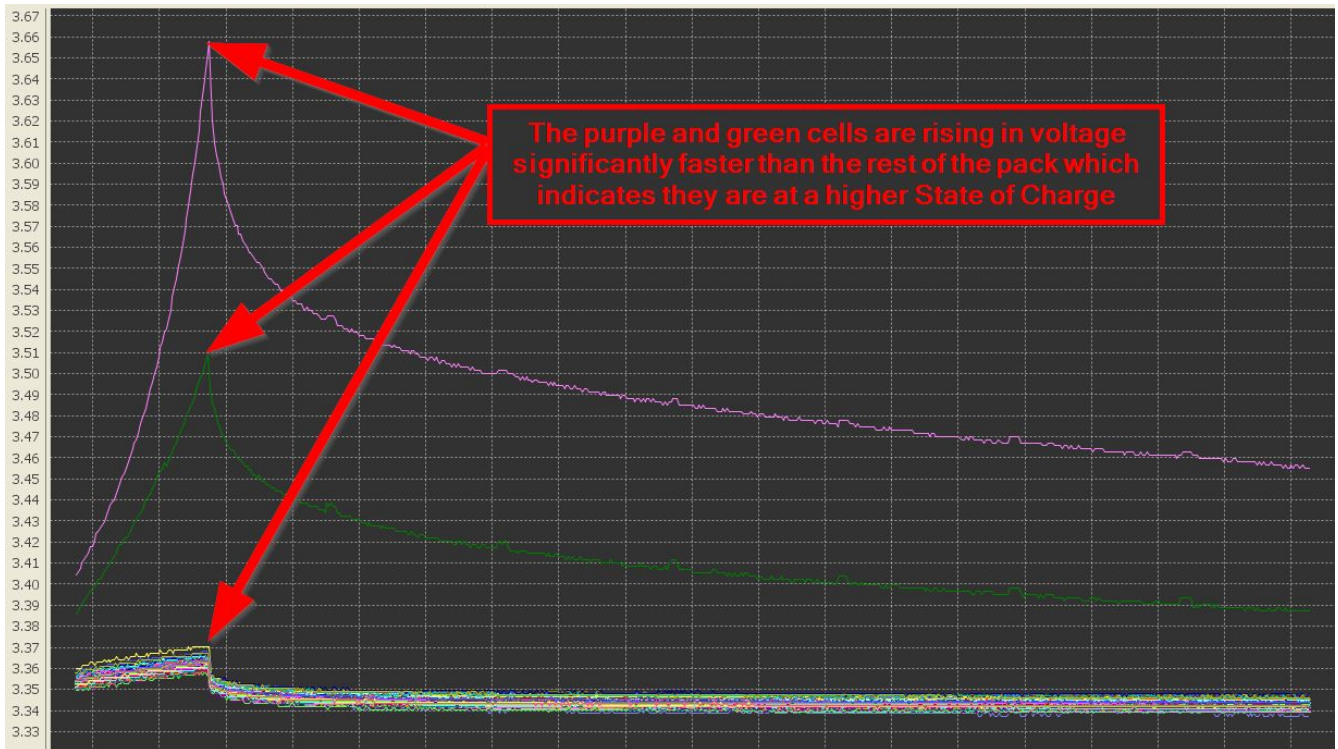
The above chart shows the termination of charge on a battery pack. There are 2 cells in this (purple and green) which are at a higher state of charge at the top of the battery pack, indicating they are out of balance with the rest of the pack. The exact amount the cells are out of balance is very difficult to determine, but given the top 2 cells reached full state of charge while the remainder are less than 3.37v under charge, they are likely considerably out of balance which would considerably limit the amount of usable range of the battery until the cells have been properly balanced.

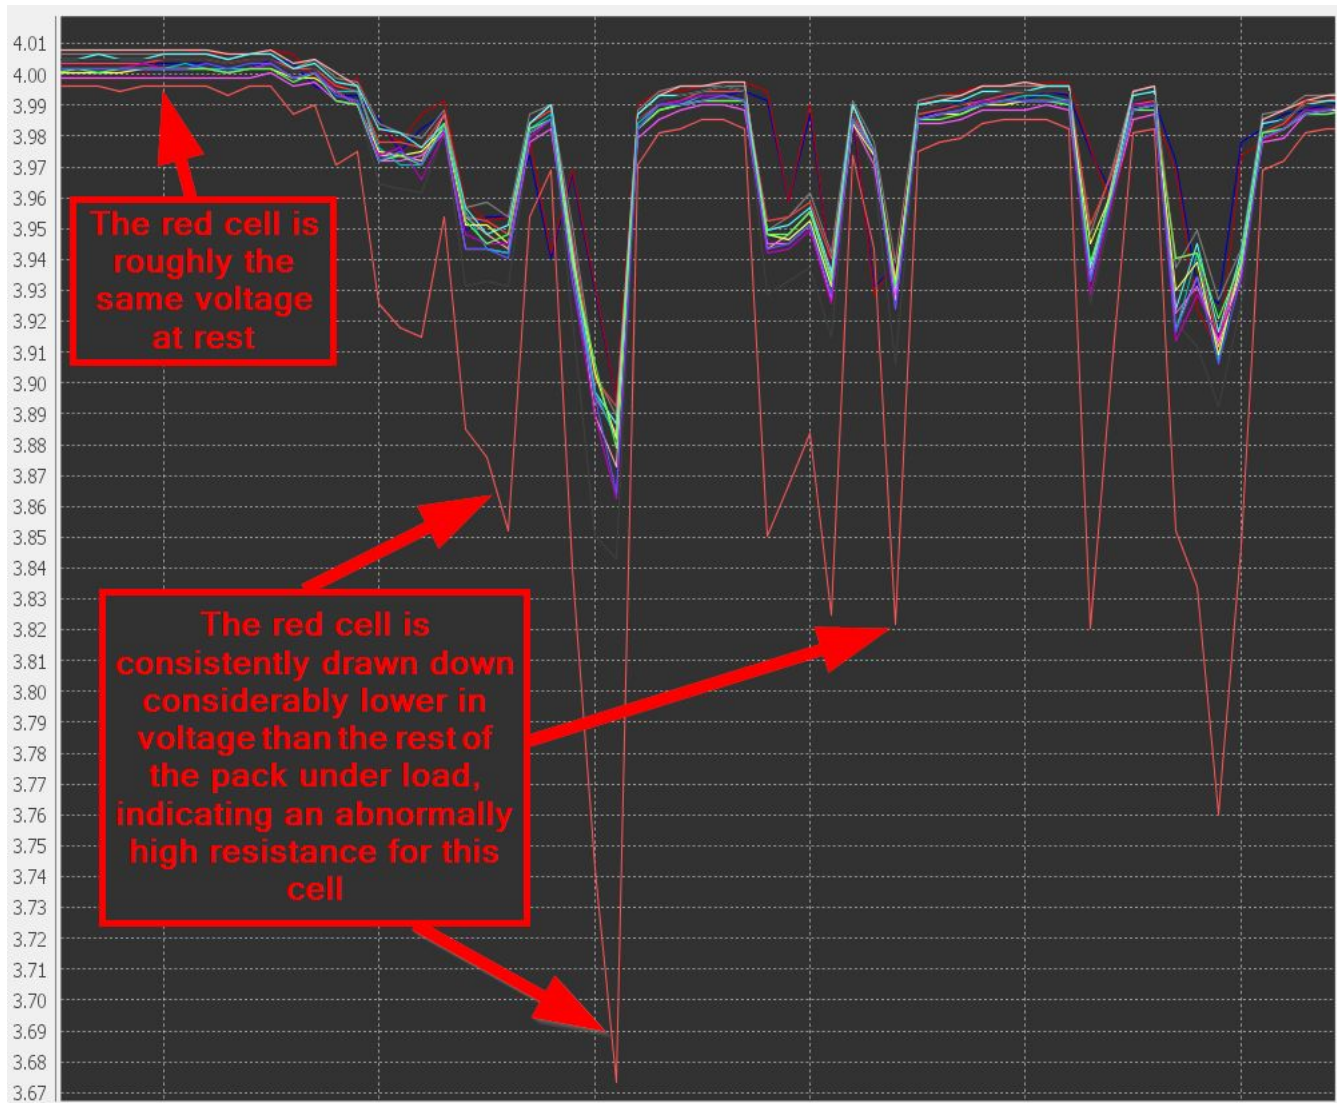
In the above image the cells all start out at roughly the same voltage and are fairly well grouped together while the battery pack is at rest. As soon as a load is applied to the battery pack, the voltage of the light orange cell drops considerably further than the rest of the cells. When the pack returns to resting conditions, the light orange cell returns to roughly the same voltage as the rest of the pack. This indicates high resistance in the cell causing excessive voltage drop on that cell. High resistance can be caused by a bad cell, a loose terminal or bad busbar. It can also be caused by a high resistance connection between the cell and an adjacent cell, such as a long busbar or long cable that has a significantly higher resistance. A high resistance cell frequently causes jumps in state of charge as the BMS will believe the cell to be low or higher than it might actually be. If the cell is genuinely bad, it must be replaced. If the terminal is loose, corroded or oxidized, it must be repaired, tightened or replaced.

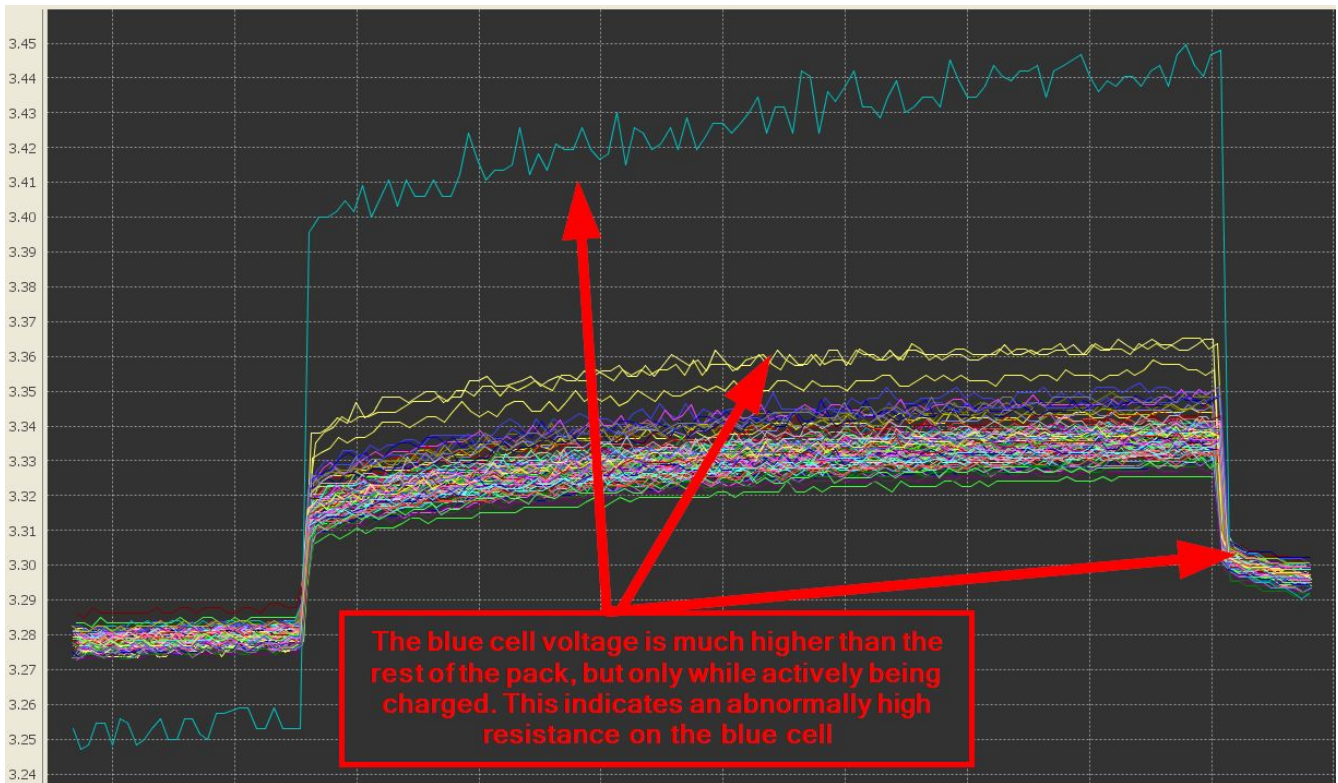
This example illustrates how an abnormally high cell resistance shows up during regular charging. Note that as soon as the charging terminates, the cell returns to a similar voltage as the rest of the pack. High resistance cells can cause pack charging to terminate prematurely because the weakest cell will hit the terminal charge voltage early.

The Orion BMS does have the ability to lower the charge current limit to reduce the impact of high resistance cells on early charge termination, however this requires a CANBUS controlled charger that supports variable output current limiting. Chargers that are either ON or OFF cannot be throttled back.

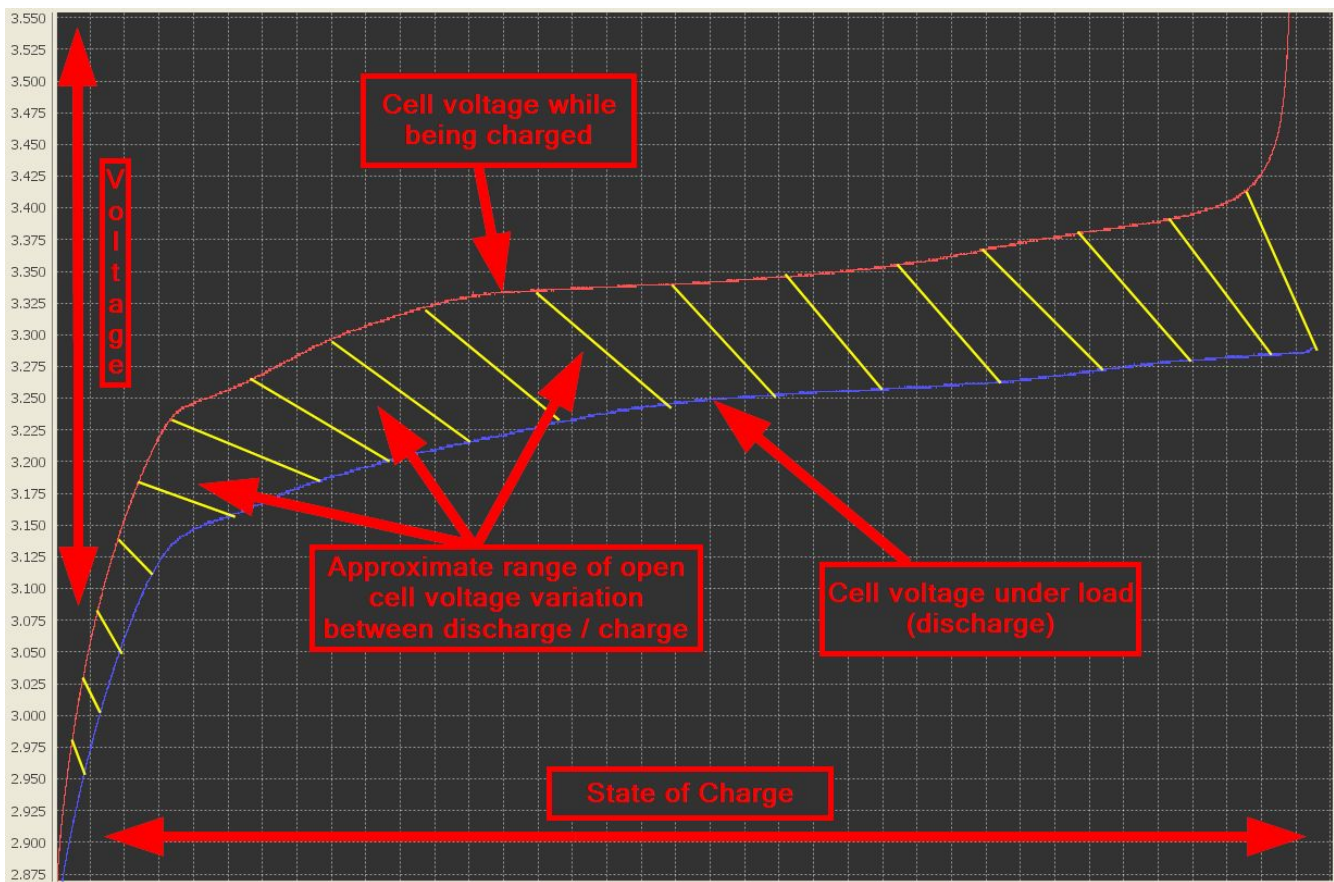
SOC correction drift points are usually selected at locations along the cell's discharge graph where the cell's state of charge is obvious and in locations where there is a significant difference in cell voltage versus state of charge. This is necessary to avoid incorrect correction drifts. While every effort is made to calculate the open circuit voltages accurately, the calculation process is not perfectly precise. There is also charge polarization on the cell which is a temporary increase or decrease in the sitting cell voltage as a result of recent charge or discharge to the cell. Both of these cause some uncertainty in the open circuit voltage calculation. For this reason, the correction drift points must be chosen such that there is some overhead. **The voltages used cannot be the exact voltage of the cell at that particular state of charge!**

Iron phosphate cells have a very flat curve in the middle of the state of charge range. In this middle range just a 50mV difference can correspond to a 75% difference in state of charge. Since calculating the open circuit voltage isn't super precise, the drift points have to have some overhead to allow for some hysteresis. For iron phosphate, that means that voltages from about 3.15 - 3.45v are not usable for drift points since the difference in voltage vs. state of charge is too small. For other chemistries, additional points throughout the full range of state of charge may be possible, improving the accuracy of the drifting, provided that the voltages leave sufficient headroom.
